# Case Study recostal® opens up the Can of Ham work flow

70 St. Mary Axe, which also goes by the unofficial architectural moniker 'Can of Ham' is a new office development with a distinctive, identifiable profile, that soars elegantly from the surrounding historic streets of the City of London.

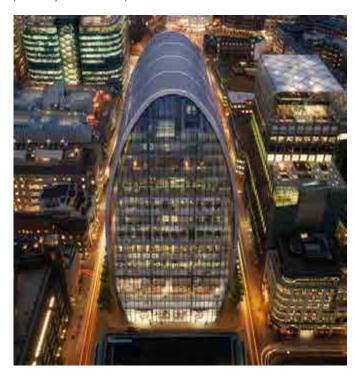
95 linear metres of recostal® 2000GTZ at a height of 1780mm was specified as the preferred shuttering to fit perfectly between top and bottom mats.

recostal® 2000GTZ goes in once and stays in as a permanent stop-end/CJ, avoiding the need for any temporary works.

Owing to its trapezoidal profile the contractor did not have to apply any retarder, jet washing or scabbling of the surface of the joint. This avoided contamination of the rebar mats.
